**Flood Control Project Maintenance
Levee Inspections**
LMA District Cover Sheet
Spring 2016 Levee Inspection Results

American River Flood Control District

Spring 2016 Levee Inspection Results

Waterway			Bank	Unit Miles
Unit No. 01 Arcade Creek			Left	2.08
	Spring (March - May)	Summer (June - August)	(September - November) Fall	Winter (December - February)
Unit Maintenance Rating (Fall Only)				
Date of Inspection	3/2/2016 - 3/2/2016			
DWR Inspector	Maksim Khashchuk			
Accompanied By	Richard Marck ARFCD			
	Sterling York

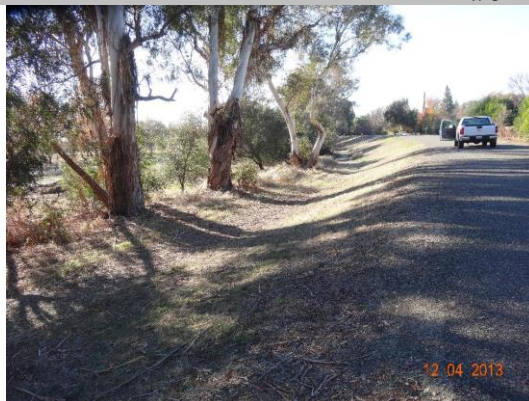
Photo 1 of 2 : UCIP_SP_2016_26281_47492.jpg

LM Start	0.72	Rating **	M	Issue No.	118
LM End	0.72	Issue Type +	En	Location *	CR
Category	Supplemental			GPS Latitude/Longitude	
				Start	End
Item	DWR UCIP Field Study			38.591003 °	38.591003 °
				-121.335459 °	-121.335459 °
DWR ID					
Comment Code					
Inspector Comment					
FS_ID:26281 DS_ID:24464 EP_NO: 12725 Repair Type: Non-Urgent Crossing Status: Indicator Found UCIP Comments: Unable to confirm if this crossing is the same under permit 12725. Drinking fountain and water flow prevention located on waterward side. Need to coordinate with American River Flood Control District. FIELD_STRUCT_DESC: 6-inch steel water pipe through the levee, 2.5 feet below the crown. Arcade Water District well at landside (LS) toe. (Permit No. 12725-1980) FS Date: 12/4/2013

View of waterward slope.

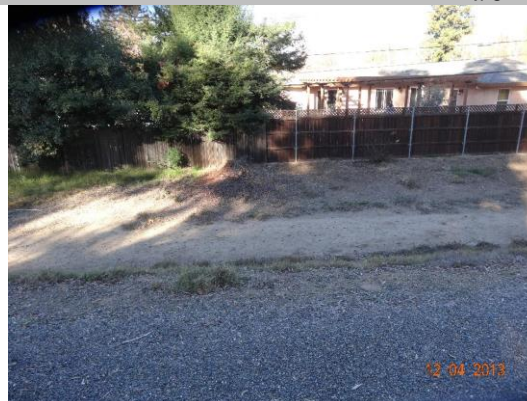
Photo 1 of 2 : UCIP_SP_2016_41550_47496.jpg

LM Start	0.94	Rating **	M	Issue No.	129
LM End	0.94	Issue Type +	En	Location *	CR
Category	Supplemental			GPS Latitude/Longitude	
				Start	End
Item	DWR UCIP Field Study			38.587989 °	38.587989 °
				-121.336773 °	-121.336773 °
DWR ID					
Comment Code					
Inspector Comment					
FS_ID:41550 DS_ID:24413 EP_NO: 2806 Repair Type: Non-Urgent Crossing Status: Found UCIP Comments: Need to determine status of crossing--Need to coordinate with utility owner. FIELD_STRUCT_DESC: 30-inch corrugated metal (CM) pipe through the levee, 15.0 feet below the crown. Cutoff wall around pipe under landside (LS) shoulder. Flap gate and slide gate in concrete pipe well on the waterside (WS) shoulder. Large drain canal cut across the WS berm. (Permit No. 2806-1958) FS Date: 12/4/2013

View of landward side.

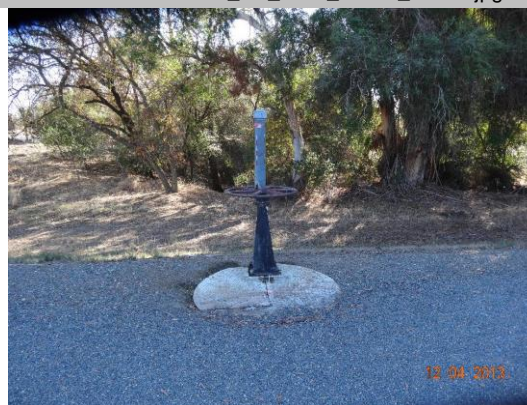
Photo 2 of 2 : UCIP_SP_2016_41550_47495.jpg

View of gate steam located on waterward shoulder.

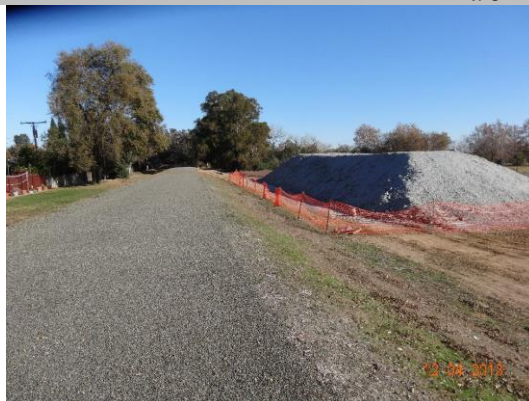
Photo 1 of 2 : UCIP_SP_2016_31284_57285.jpg

LM Start	1.04	Rating **	M	Issue No.	125
LM End	1.04	Issue Type +	En	Location *	CR
Category	Supplemental			GPS Latitude/Longitude	
				Start	End
Item	DWR UCIP Field Study			38.586813 °	38.586813 °
				-121.337643 °	-121.337643 °
DWR ID					
Comment Code					
Inspector Comment					
FS_ID:31284 DS_ID:24821 EP_NO: N/A Repair Type: Non-Urgent Crossing Status: Found UCIP Comments: Unable to determine reason for box and whether there is a utility that crosses levee. No permit found. FIELD_STRUCT_DESC: Service box located on waterside (WS). No permit found. FS Date: 12/4/2013

Overview of levee crown at crossing.

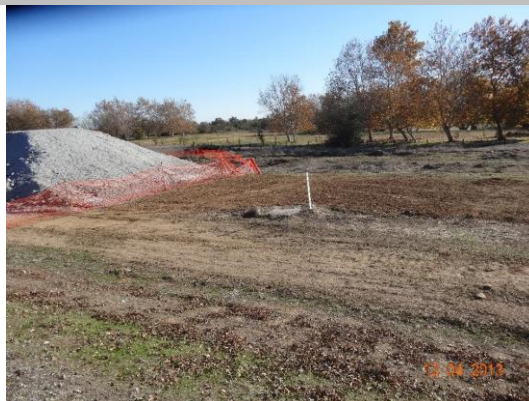
Photo 2 of 2 : UCIP_SP_2016_31284_57286.jpg

Concrete vault located on waterward side.

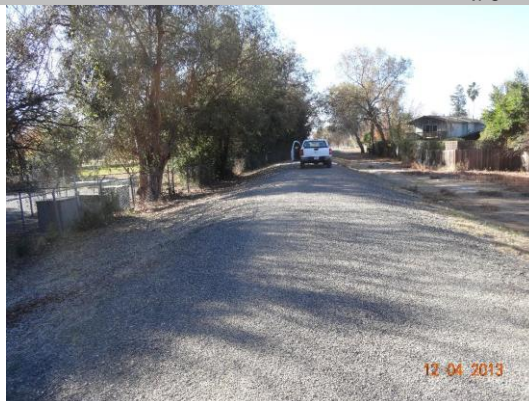
Photo 1 of 2 : UCIP_SP_2016_41536_47550.jpg

LM Start	1.28	Rating **	M	Issue No.	126
LM End	1.28	Issue Type +	En	Location *	CR
Category	Supplemental			GPS Latitude/Longitude	
				Start	End
Item	DWR UCIP Field Study			38.583873 °	38.583873 °
				-121.340037 °	-121.340037 °
DWR ID					
Comment Code					
Inspector Comment					
FS_ID:41536					
DS_ID:24097					
EP_NO: 12276					
Repair Type: Non-Urgent					
Crossing Status: Indicator Found					
UCIP Comments: Unable to find markers indicating crossing through levee.					
FIELD_STRUCT_DESC: Two 3-inch PVC electrical conduits through the levee, 3.0 feet below the crown. Northeast Sewage Treatment Plant on waterside (WS). Conduits extend from treatment plant to transformers located on WS. (Permit No. 12276-1980)					
FS Date: 12/4/2013

Overview of levee looking downstream.

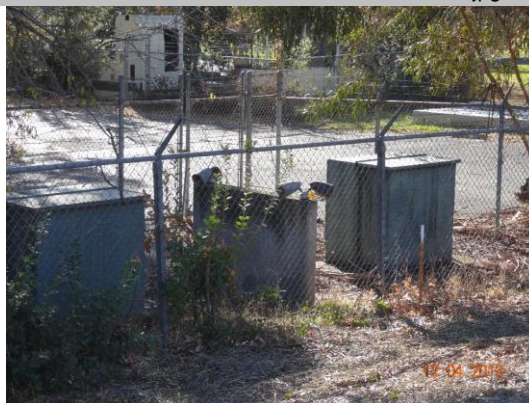
Photo 2 of 2 : UCIP_SP_2016_41536_47549.jpg

View of transformers located on waterward side.

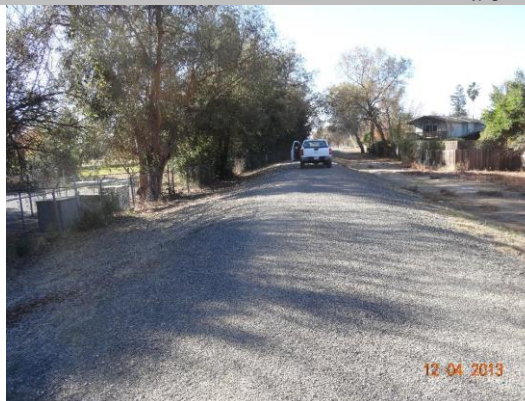
Photo 1 of 2 : UCIP_SP_2016_26299_47575.jpg

LM Start	1.28	Rating **	M	Issue No.	121
LM End	1.28	Issue Type +	En	Location *	CR
Category	Supplemental			GPS Latitude/Longitude	
				Start	End
Item	DWR UCIP Field Study			38.583873 °	38.583873 °
				-121.340037 °	-121.340037 °
DWR ID					
Comment Code					
Inspector Comment					
FS_ID:26299 DS_ID:24477 EP_NO: 7993 Repair Type: Non-Urgent Crossing Status: Found UCIP Comments: Unable to confirm if crossing buried is the same as this crossing. Need to contact owner to confirm utility description. FIELD_STRUCT_DESC: 6-inch plastic lined steel pipe through the levee at unknown depth. Steel cutoff wall around pipe at center of levee. (Permit No. 7993-1973) FS Date: 12/4/2013

Overview of levee crown looking downstream.

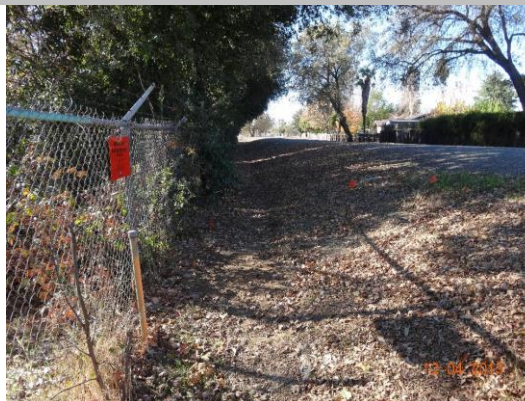
Photo 2 of 2 : UCIP_SP_2016_26299_47574.jpg

View of waterward side--Underground Alert System markers showing alignment.

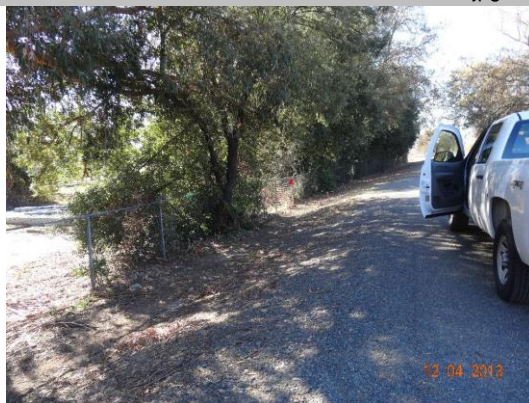
Photo 2 of 2 : UCIP_SP_2016_26296_47559.jpg

FS_ID:26296
DS_ID:24568
EP_NO: 3599B
Repair Type: Non-Urgent
Crossing Status: Indicator Found
UCIP Comments: Need to determine status of structure-unable to determine if crossing is being used. Only indicator visible during inspection was the underground alert service markers and spray paint visible on the levee crown.
FIELD_STRUCT_DESC: 1 of 3: [River Walkway Station] 12-inch concrete encased pipe through the levee, 15.3 feet below the crown. Two cutoff walls around pipe in line with each shoulder. Slide gate in concrete gate structure at landside (LS) toe-not found 2013. Sewage treatment plant on waterside (WS). Control valve in concrete box on the WS. (Permit No. 3599B-1964) Contact: Sacramento Regional Office 875-9400; Oscar Starks (Supervisor) 916-204-5143; Troy Shurock 916-599-2413.
FS Date: 12/4/2013

View of waterward side.

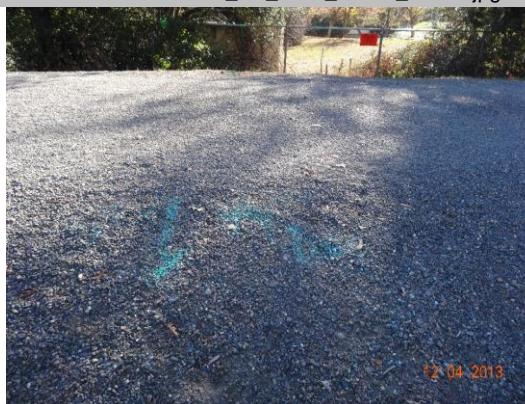
Photo 2 of 2 : UCIP_SP_2016_26298_47571.jpg

Comment Code					
Inspector Comment					
FS_ID:26298 DS_ID:24567 EP_NO: 3599A Repair Type: Non-Urgent Crossing Status: Found UCIP Comments: Need to determine status of structure. Need to coordinate with owner to determine maintenance records to confirm integrity. FIELD_STRUCT_DESC: 2 of 3: [River Walkway Station] 36-inch concrete encased pipe through the levee, 6.9 feet below the crown. Two cutoff walls around pipe in line with each shoulder. Slide gate in concrete gate structure at landside (LS) toe. Sewage treatment plant on waterside (WS). Control valve in concrete box on the WS. (Permit No. 3599A-1964) Contact: Sacramento Regional Office 875-9400; Oscar Starks (Supervisor) 916-204-5143; Troy Shurock 916-599-2413. FS Date: 12/4/2013

USA markers indicate alignment through levee crown.

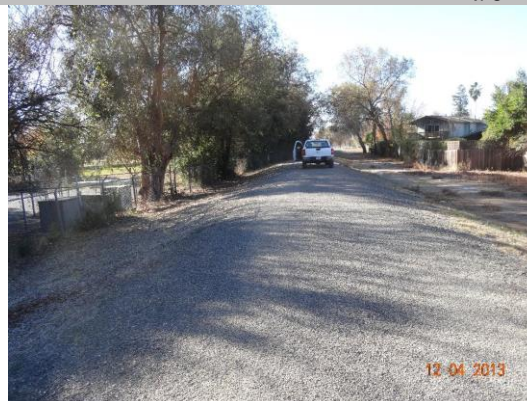
Photo 1 of 2 : UCIP_SP_2016_26426_47982.jpg

FS_ID:26426
DS_ID:24098
EP_NO: 3599
Repair Type: Non-Urgent
Crossing Status: Indicator Found
UCIP Comments: Need to determine status of structure--unable to determine if crossing is still being used. Underground service alert (USA) flag indicates 60 inch pipe through levee. Need to clarify.
FIELD_STRUCT_DESC: 3 of 3: [River Walkway Station] 54-inch concrete encased pipe through the levee, 8.5 feet below the crown. Two cutoff walls around pipe in line with each shoulder. Slide gate in concrete gate structure at landside (LS) toe. Sewage treatment plant on waterside (WS). Control valve in concrete box on the WS. (Permit No. 3599-1964) Contact: Sacramento Regional Office 875-9400; Oscar Starks (Supervisor) 916-204-5143; Troy Shurock 916-599-2413.
FS Date: 12/4/2013

Overview of levee crown looking downstream.

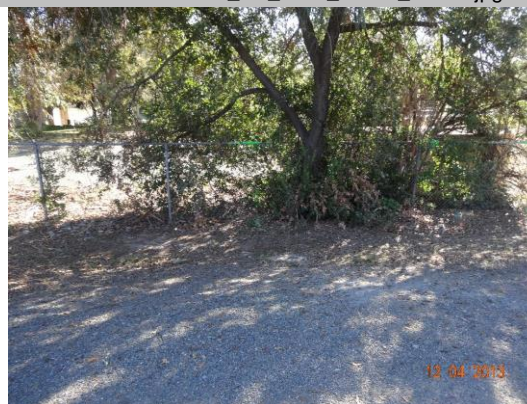
Photo 2 of 2 : UCIP_SP_2016_26426_47980.jpg

View of Underground Service Alert (USA) markers and flags confirming buried sewer lines.

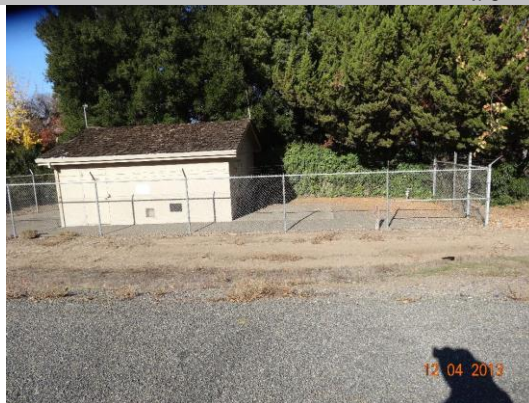
Photo 1 of 2 : UCIP_SP_2016_41548_54880.jpg

FS_ID:41548
DS_ID:24419
EP_NO: N/A
Repair Type: Non-Urgent
Crossing Status: Found
UCIP Comments: Need to find out the status of crossing--unable to determine if crossing is being used.
FIELD_STRUCT_DESC: 24-inch pipe through the levee, 7.0 feet below the crown. Concrete inspection box at waterside (WS) toe.
FS Date: 12/4/2013

Structure located on landward side.

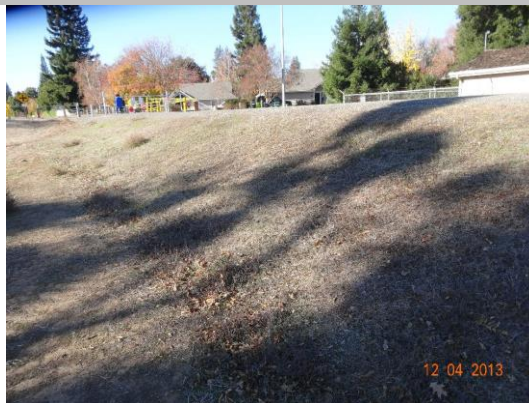
Photo 2 of 2 : UCIP_SP_2016_41548_54881.jpg

View of waterward side.

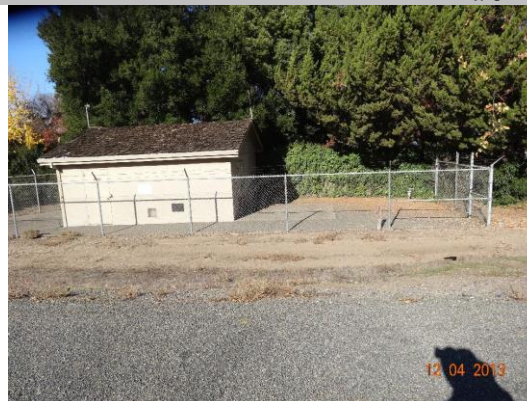
Photo 1 of 2 : UCIP_SP_2016_41546_57290.jpg

LM Start	1.53	Rating **	M	Issue No.	127
LM End	1.53	Issue Type +	En	Location *	CR
Category	Supplemental			GPS Latitude/Longitude	
				Start	End
Item	DWR UCIP Field Study			38.581588 °	38.581588 °
				-121.343631 °	-121.343631 °
DWR ID					
Comment Code					
Inspector Comment					
FS_ID:41546 DS_ID:24101 EP_NO: N/A Repair Type: Non-Urgent Crossing Status: Found UCIP Comments: Need to determine the status of crossing--unable to determine if crossing is still active. FIELD_STRUCT_DESC: 8-inch pipe through the levee. Concrete inspection box on the landside (LS) slope. FS Date: 12/4/2013

Structure located on waterward side.

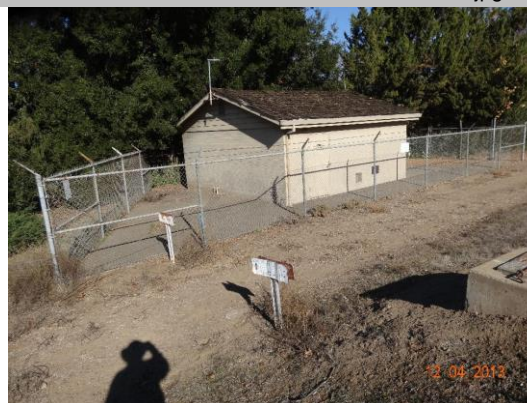
Photo 2 of 2 : UCIP_SP_2016_41546_57289.jpg

View of landward side--chlorine line adjacent to 8-inch pipe.

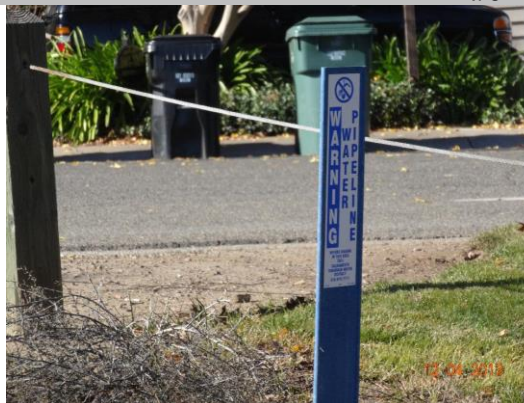
Photo 1 of 2 : UCIP_SP_2016_30575_56338.jpg

FS_ID:30575
DS_ID:24822
EP_NO: N/A
Repair Type: Non-Urgent
Crossing Status: Indicator Found
UCIP Comments: 2nd marker visible on landward side at levee mile 1.63 (38.581564 -121.343806).
FIELD_STRUCT_DESC: Marker indicating water line located on landside (LS) toe. Unable to determine if line runs parallel to levee or if line crosses levee. Unable to find permit for work.
FS Date: 12/4/2013

Waterline marker at levee mile 1.63.

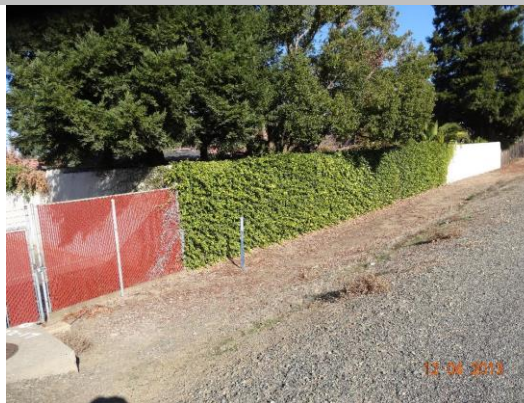
Photo 2 of 2 : UCIP_SP_2016_30575_56337.jpg

Waterline marker at levee mile 1.7.

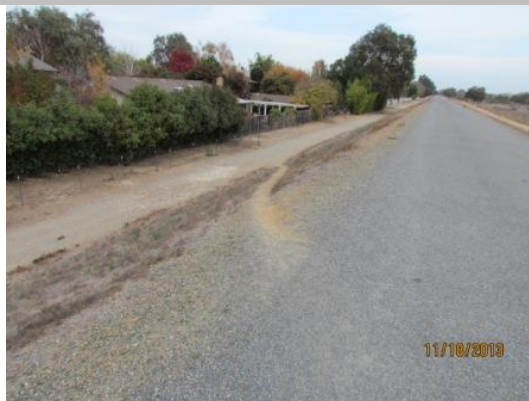
Photo 1 of 1 : SP_2016_NA0001_61_7_20160229_00003.jpg

LM Start	2.41	Rating **	A/W	Issue No.	7
LM End	2.41	Issue Type +	Ma	Location *	LS
Category	Earthen Levee			GPS Latitude/Longitude	
				Start	End
Item	Slope Stability			38.575126 °	38.575126 °
				-121.357575 °	-121.357575 °
DWR ID	DWR_NA0001_10_f_2013_7				
Comment Code					
S2 : Repair the levee slope damaged by foot traffic and prevent access where possible.					
Inspector Comment

View of the pathway on the landside levee slope.

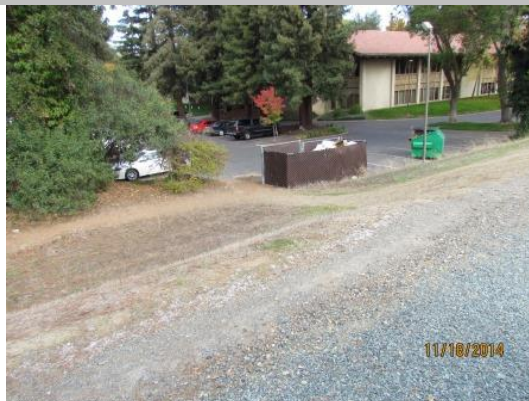
Photo 1 of 1 : SP_2016_NA0001_61_116_20160229_00007.jpg

LM Start	3.74	Rating **	A/W	Issue No.	116
LM End	3.74	Issue Type +	Ma	Location *	LS
Category	Earthen Levee			GPS Latitude/Longitude	
				Start	End
Item	Slope Stability			38.568526 °	38.568526 °
				-121.380331 °	-121.380331 °
DWR ID	DWR_NA0001_10_s_2012_116				
Comment Code					
S2 : Repair the levee slope damaged by foot traffic and prevent access where possible.					
Inspector Comment					
Foot traffic is eroding the landside slope.

View of the erosion on the landside levee slope caused by pedestrian foot traffic.

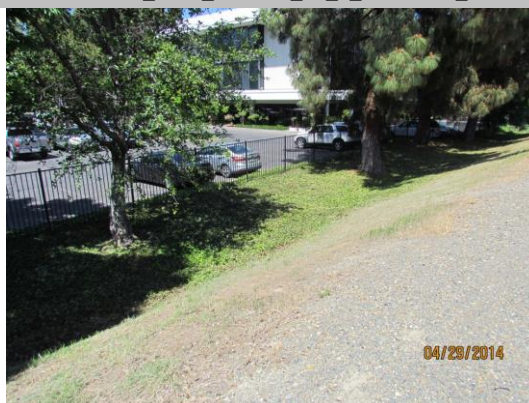
Photo 1 of 1 : SP_2016_NA0001_61_4_20160229_00001.jpg

LM Start	3.75	Rating **	A/W	Issue No.	4
LM End	3.84	Issue Type +	En	Location *	LS
Category	Earthen Levee			GPS Latitude/Longitude	
				Start	End
Item	Vegetation			38.568492 °	38.568076 °
				-121.380477 °	-121.382001 °
DWR ID	DWR_NA0001_10_s_2012_4				
Comment Code					
V6 : Landscaping					
Inspector Comment					
Ivy and trees.

View of the landscaping at the landside levee toe and slope.

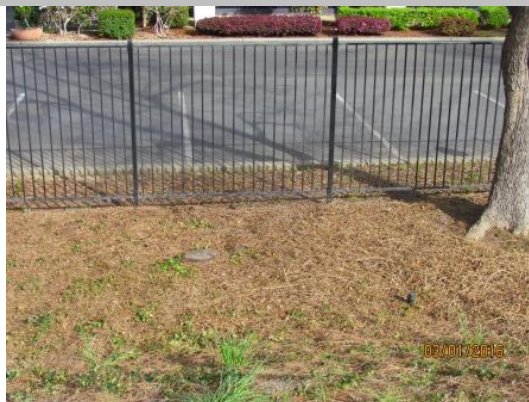
Photo 1 of 1 : SP_2016_NA0001_61_26_20160307_00042.jpg

LM Start	3.81	Rating **	N	Issue No.	26
LM End	3.81	Issue Type +	Ma	Location *	LS
Category	Earthen Levee			GPS Latitude/Longitude	
				Start	End
Item	Trim / Thin Trees			38.568190 °	38.568190 °
				-121.381510 °	-121.381510 °
DWR ID	DWR_NA0001_10_s_2016_26				
Comment Code					
T5 : Tree stumps.					
Inspector Comment

View of the tree stump at the landside levee toe.

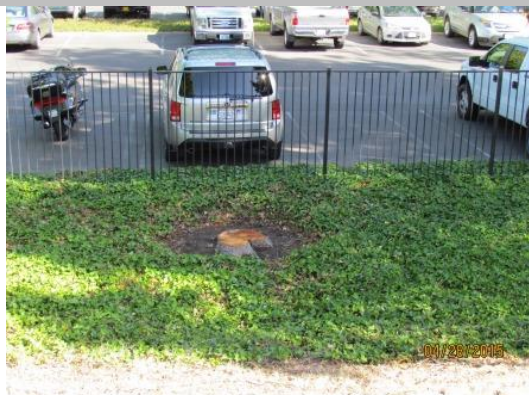
Photo 1 of 1 : SP_2016_NA0001_61_23_20160229_00006.jpg

LM Start	3.83	Rating **	N	Issue No.	23
LM End	3.83	Issue Type +	Ma	Location *	LS
Category	Earthen Levee			GPS Latitude/Longitude	
				Start	End
Item	Trim / Thin Trees			38.568111 °	38.568111 °
				-121.381896 °	-121.381896 °
DWR ID	DWR_NA0001_10_s_2015_23				
Comment Code					
T5 : Tree stumps.					
Inspector Comment

View of the tree stump at the landside levee toe.

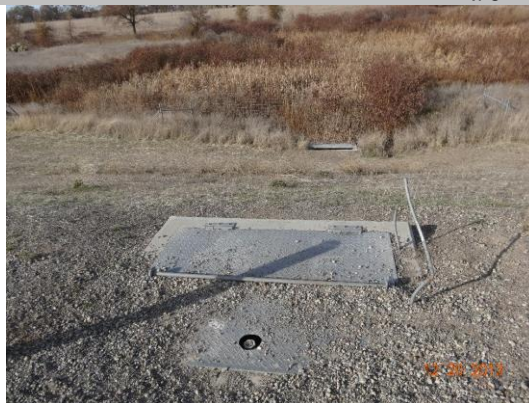
Photo 1 of 2 : UCIP_SP_2016_31310_57345.jpg

FS_ID:31310
DS_ID:24823
EP_NO: N/A
Repair Type: Non-Urgent
Crossing Status: Found
UCIP Comments: no permit found--owner? (unauthorized?)
FIELD_STRUCT_DESC: 24-inch pipe through the levee at unknown depth. Concrete box located on waterside (WS) shoulder. Concrete wall located on waterside (WS) and landside (LS). Siphon breaker inside concrete service box located on WS shoulder. No permit found.
FS Date: 12/20/2013

View of waterward side.

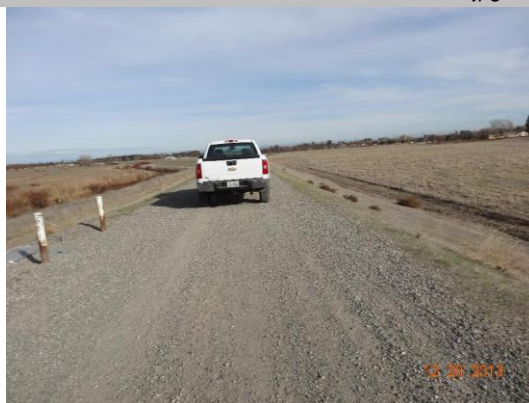
Photo 2 of 2 : UCIP_SP_2016_31310_57342.jpg

View of levee crown at crossing.

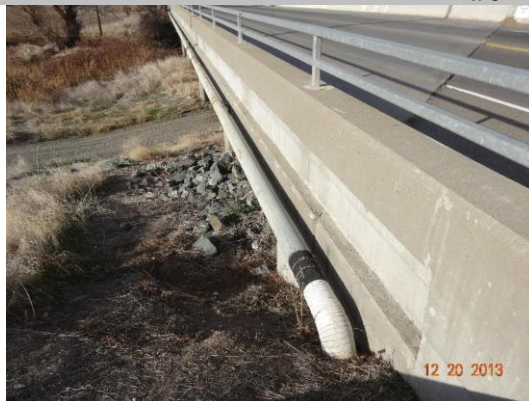
Photo 1 of 1 : UCIP_SP_2016_31311_57346.jpg

LM Start	0.48	Rating **	M	Issue No.	7
LM End	0.48	Issue Type +	En	Location *	LS
Category	Supplemental			GPS Latitude/Longitude	
				Start	End
Item	DWR UCIP Field Study			38.666585 °	38.666585 °
				-121.451009 °	-121.451009 °
DWR ID					
Comment Code					
Inspector Comment					
FS_ID:31311 DS_ID:24824 EP_NO: N/A Repair Type: Non-Urgent Crossing Status: Found UCIP Comments: owner? permit? (unauthorized?) FIELD_STRUCT_DESC: 6 inch conduit through levee at unknown depth. Conduit extends across the channel, attached to bridge. FS Date: 12/20/2013

Crossing visible on waterward side.

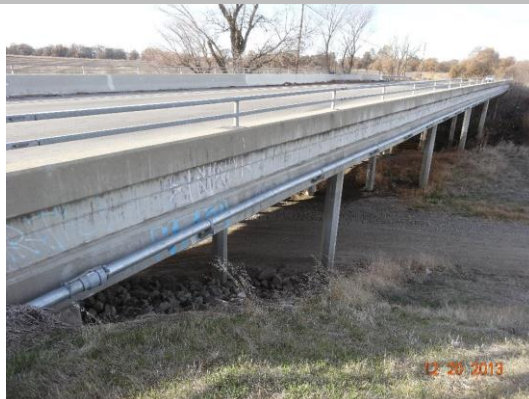
Photo 1 of 1 : UCIP_SP_2016_31312_57347.jpg

LM Start	0.49	Rating **	M	Issue No.	8
LM End	0.49	Issue Type +	En	Location *	LS
Category	Supplemental			GPS Latitude/Longitude	
				Start	End
Item	DWR UCIP Field Study			38.666745 °	38.666745 °
				-121.450918 °	-121.450918 °
DWR ID					
Comment Code					
Inspector Comment					
FS_ID:31312					
DS_ID:24825					
EP_NO: N/A					
Repair Type: Non-Urgent					
Crossing Status: Found					
UCIP Comments: owner? permit? (unauthorized?)					
FIELD_STRUCT_DESC: 4 inch conduit through levee at unknown					
depth. Conduit extends across the channel, attached to bridge.					
FS Date: 12/20/2013

Conduit attached to the upstream face of Rio Linda Blvd Bridge.

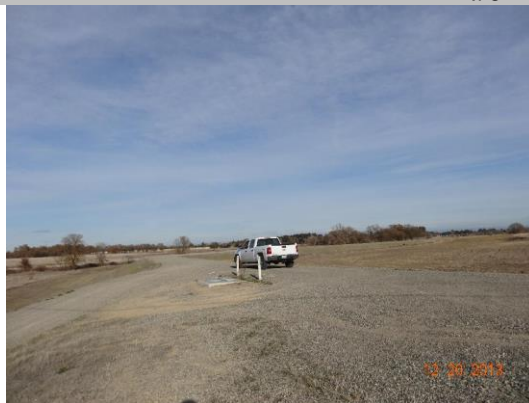
Photo 1 of 2 : UCIP_SP_2016_31313_57349.jpg

LM Start	0.52	Rating **	M	Issue No.	9
LM End	0.52	Issue Type +	En	Location *	LS
Category	Supplemental			GPS Latitude/Longitude	
				Start	End
Item	DWR UCIP Field Study			38.667108 °	38.667108 °
				-121.450827 °	-121.450827 °
DWR ID					
Comment Code					
Inspector Comment					
FS_ID:31313 DS_ID:24826 EP_NO: N/A Repair Type: Non-Urgent Crossing Status: Found UCIP Comments: owner? permit? (unauthorized?) FIELD_STRUCT_DESC: 24-inch (estimate only field verify) storm drain pipe through levee at an unknow depth. Concrete headwalls with debris screens located on waterside (WS) and landside (LS). Concrete box with protective posts located on WS shoulder. No permit found. FS Date: 12/20/2013

View of levee crown at crossing.

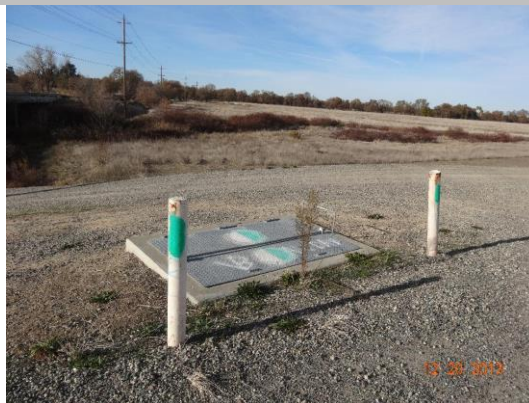
Photo 2 of 2 : UCIP_SP_2016_31313_57348.jpg

Concrete vault with protective posts located on waterward shoulder.

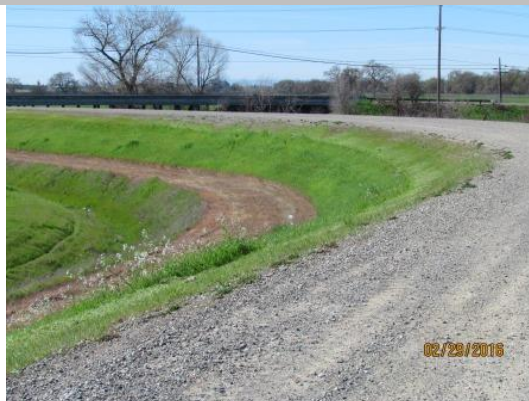
Photo 1 of 1 : SP_2016_NA0001_436_5_20160307_00009.jpg

LM Start	0.60	Rating **	A	Issue No.	5
LM End	0.60	Issue Type +	Ma	Location *	LS
Category	Earthen Levee			GPS Latitude/Longitude	
				Start	End
Item	Vegetation			38.667896°	38.667896°
				-121.449796°	-121.449796°
DWR ID	DWR_NA0001_11_s_2016_5				
Comment Code					
V1 : Control annual grass and weeds on the levee slopes and easements.					
Inspector Comment

View of the vegetation on the landside levee slope, looking downstream.

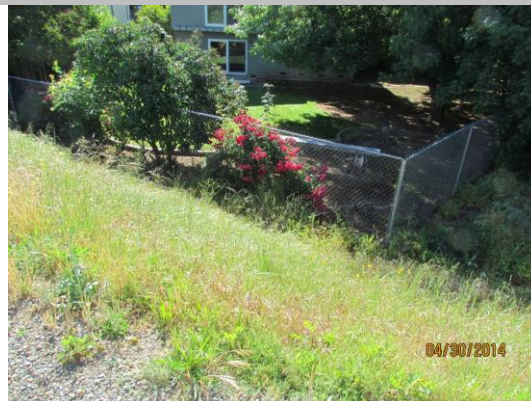
Photo 1 of 1 : SP_2016_NA0001_438_2_20160229_00002.jpg

LM Start	0.08	Rating **	M	Issue No.	2
LM End	0.08	Issue Type +	En	Location *	LS
Category	Earthen Levee			GPS Latitude/Longitude	
				Start	End
Item	Vegetation			38.571036 °	38.571036 °
				-121.353441 °	-121.353441 °
DWR ID	DWR_NA0001_12_s_2014_2				
Comment Code					
V6 : Landscaping					
Inspector Comment

View of the landscaping at the landside levee toe.

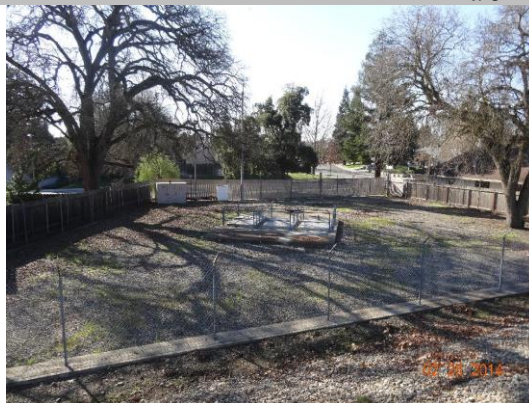
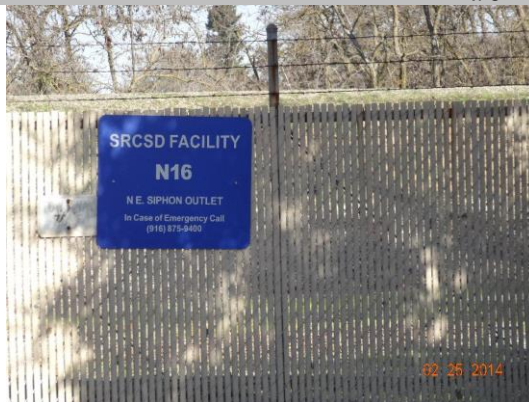
Comment Code					
Inspector Comment					
FS_ID:46995 DS_ID:24830 EP_NO: N/A Repair Type: Non-Urgent Crossing Status: Indicator Found UCIP Comments: Unable to confirm pipe size--need to contact owner to obtain additional information on crossing. FIELD_STRUCT_DESC: [SRCSD Facility N16 NE Siphon Outlet] 1 of 3: 48-inch reinforced concrete (RC) drainpipe through the levee at 11.0 feet below crown. Pipe crosses levee at an angle. Sacramento Regional County Sanitation District (SRCSD) Facility N16 NE Siphon Outlet located on landside (LS). Facility is fenced off. Inside facility are 3 concrete boxes with 3 manholes. (Permit No. 12144-1978, SRCSD and 12144-A-1983, SRCSD for cathodic protection) FS Date: 2/25/2014

LM Start	0.72	Rating **	M	Issue No.	7 (cont)
LM End	0.72	Issue Type +	En	Location *	LS

Concrete vault located on landward side.

SRCSD Facility N16, NE Siphon Outlet, sign visible from Mira Del Rio Drive.

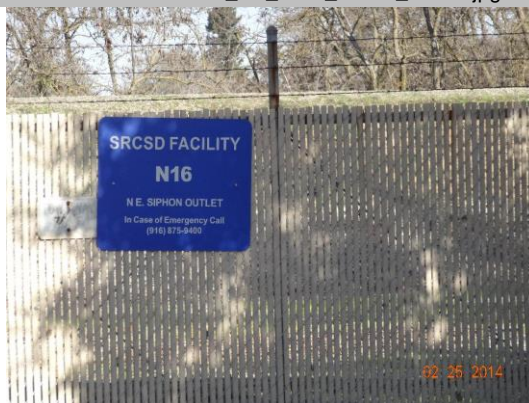
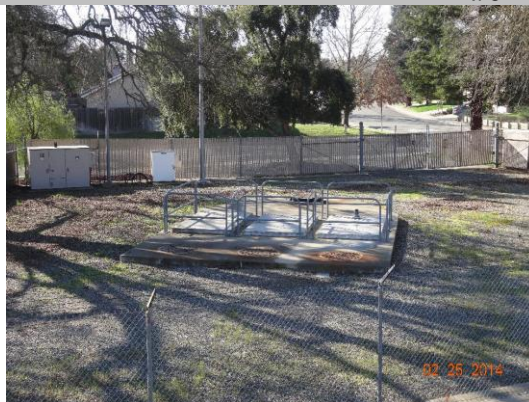
Comment Code					
Inspector Comment					
FS_ID:30540					
DS_ID:24829					
EP_NO: N/A					
Repair Type: Non-Urgent					
Crossing Status: Indicator Found					
UCIP Comments: Unable to confirm pipe size--need to contact owner to obtain additional information on crossing.					
FIELD_STRUCT_DESC: [SRCSD Facility N16 NE Siphon Outlet] 2 of 3: 48-inch reinforced concrete (RC) drainpipe through the levee at 11.0 feet below crown. Pipe crosses levee at an angle. Sacramento Regional County Sanitation District (SRCSD) Facility N16 NE Siphon Outlet located on landside (LS). Facility is fenced off. Inside facility are 3 concrete boxes with 3 manholes. (Permit No. 12144-1978, SRCSD and 12144-A-1983, SRCSD for cathodic protection)					
FS Date: 2/25/2014

LM Start	0.72	Rating **	M	Issue No.	5 (cont)
LM End	0.72	Issue Type +	En	Location *	LS

SRCSD Facility N16, NE Siphon Outlet, sign visible from Mira Del Rio Drive.

Manholes visible on landward side.

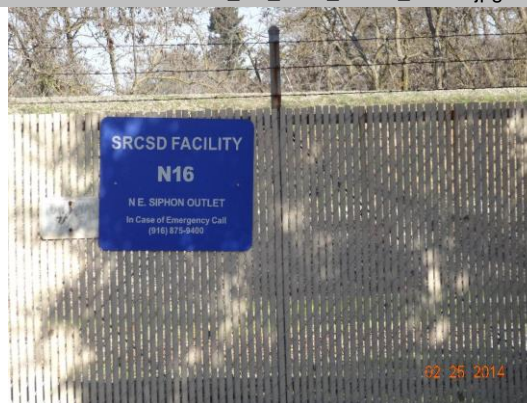
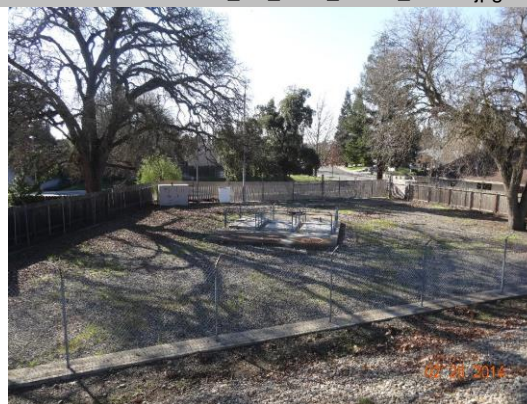
Comment Code					
Inspector Comment					
FS_ID:46994 DS_ID:24828 EP_NO: N/A Repair Type: Non-Urgent Crossing Status: Indicator Found UCIP Comments: Unable to confirm pipe size--need to contact owner to obtain additional information on crossing. FIELD_STRUCT_DESC: [SRCSD Facility N16 NE Siphon Outlet] 3 of 3: 48-inch reinforced concrete (RC) drainpipe through the levee at 11.0 feet below crown. Pipe crosses levee at an angle. Sacramento Regional County Sanitation District (SRCSD) Facility N16 NE Siphon Outlet located on landside (LS). Facility is fenced off. Inside facility are 3 concrete boxes with 3 manholes. (Permit No. 12144-1978, SRCSD and 12144-A-1983, SRCSD for cathodic protection) FS Date: 2/25/2014

LM Start	0.72	Rating **	M	Issue No.	6 (cont)
LM End	0.72	Issue Type +	En	Location *	LS

SRCDS Facility N16, NE Siphon Outlet, sign visible from Mira Del Rio Drive.

Concrete vault for 3 crossings located on landward side.

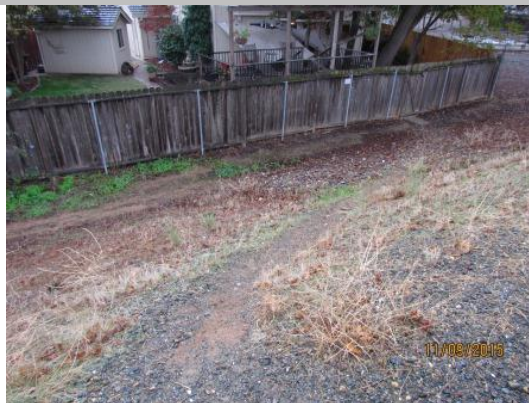
Photo 1 of 1 : SP_2016_NA0001_438_3_20160229_00003.jpg

LM Start	0.73	Rating **	A/W	Issue No.	3
LM End	0.73	Issue Type +	Ma	Location *	LS
Category	Earthen Levee			GPS Latitude/Longitude	
				Start	End
Item	Slope Stability			38.576663 °	38.576663 °
				-121.343805 °	-121.343805 °
DWR ID	DWR_NA0001_12_f_2015_3				
Comment Code					
S2 : Repair the levee slope damaged by foot traffic and prevent access where possible.					
Inspector Comment

View of the footpath on the landside levee slope.
